CONNECTICUT COASTAL BASIN  
GREENWICH, CONNECTICUT  
**CONVERSE LAKE DAM**  
**CT 00044**

PHASE I INSPECTION REPORT  
NATIONAL DAM INSPECTION PROGRAM

February 1980

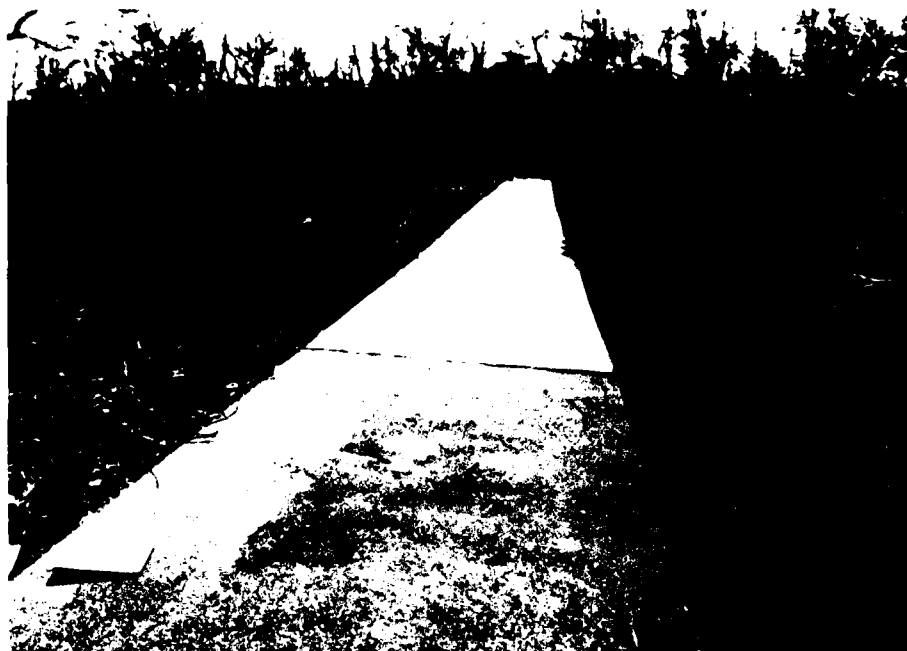
Crest - The top of the dam is a concrete cap and is in good condition (Photo 1). Minor spalling of the concrete was observed on the upstream edge of the left portion of the crest.

Photo 1 - Crest of dam from left abutment (Nov. 1979).
